## Failure analysis in 316L stainless steel supracondylar blade plate☆

L. Guerra-Fuentes, E. Garcia-Sanchez, A. Juarez-Hernandez, M.A.L. Hernandez-Rodriguez\*

Universidad Autónoma de Nuevo León, Facultad de Ingeniería Mecánica y Eléctrica, San Nicolás de los Garza, N.L., Mexico

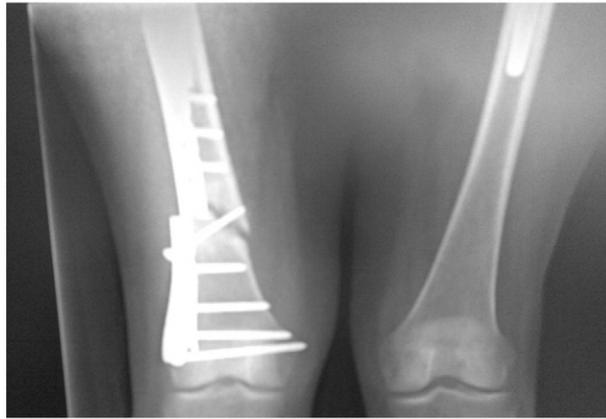
Fig. 1. X-ray image showing the bone and the failed supracondylar plate.

Fig. 1 shows an X-ray radiograph of the fracture where the two screws that stabilize the small third fragment are inserted in lag screw fashion and compress the fracture gaps of the femur near to the knee joint along with the supracondylar blade plate.

The fixation screws responsible for fastening the compression plate on the bone may easily loosen, if it has not allowed for sufficient time so that significant development of the bone tissue surrounding the fracture to occur [21]. In this case and according to the observations in the X-ray image (Fig. 1), because of the curvature of the bone the plate was not anatomically fitted to the bone. Upon placing the plate screws in the bone these were fixed with an initial tension state, promoting fatigue by the natural movement of the patient and the well known difference of mechanical properties between the steel and bone caused a quick release and a concentration of stresses; these efforts were higher than conventional because the position of the plate and the quality of the bone, based on Fig. 1, increased the propagation rate of crack and subsequent failure.

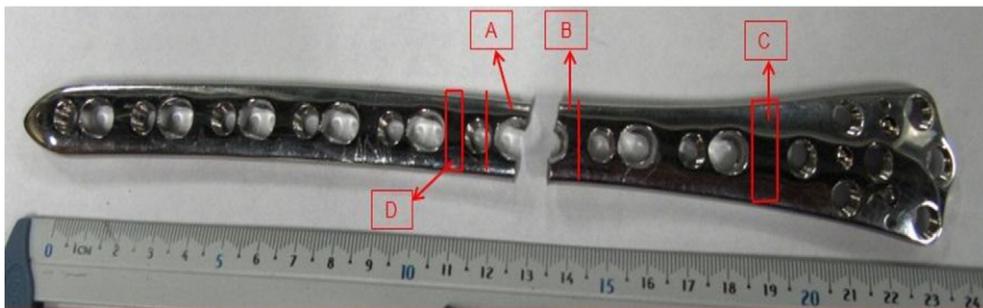
The failure of the supracondylar blade plate is shown in Fig. 2. The plate was cleaned carefully using a solution of ethanol and methanol using an ultrasonic cleaner. Different sections were selected and sectioned: “A”, “B”, “C” and “D” regions were prepared for fractographic and metallographic inspection (Fig. 2). Sections “A” and “B” correspond to the fracture area which was analyzed using a FEI Nova NanoSEM 200 with a voltage of 20 kV. In order to analyze the topography of the fracture, it was used in secondary electron mode and backscattered electrons to analyze impurities present in the failure. Sections “C” and “D” were used to analyze the microstructure; for this purpose these sections were metallographically prepared and chemically etched using a saturated solution of 2% ferric chloride in 98% of HCl by immersion; additionally chemical composition was obtained using atomic absorption spectroscopy.

Fig. 2. Supracondylar plate showing the transversal fracture through one of the holes. Sections A, B, C and D were used to the chemical and metallographic material characterization and fractographic analysis.

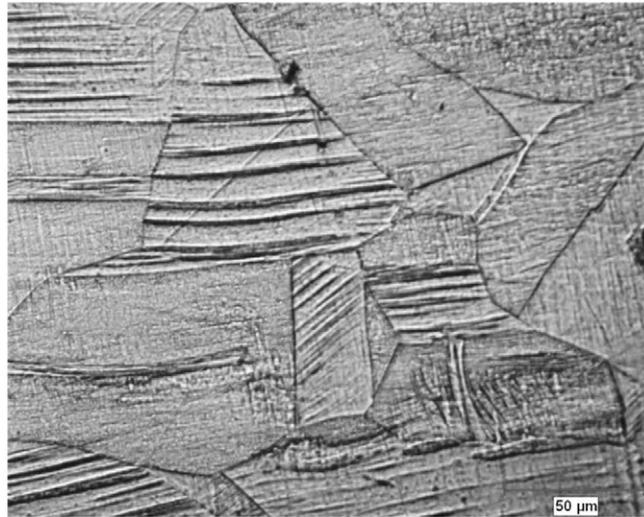
Fig. 3 shows the microstructure of the supracondylar blade plate; a typical austenitic 316L microstructure with twins in some grains which correspond to the pre-deformation of the material during its processing can be observed. Twinning is generally considered as a deformation mechanism that is activated at high strain rates [15–18]. The average microhardness is 320 HV; this value is in agreement with others reported in similar plates [2,19].

Fig. 3. Micrograph of section "D" with etching.

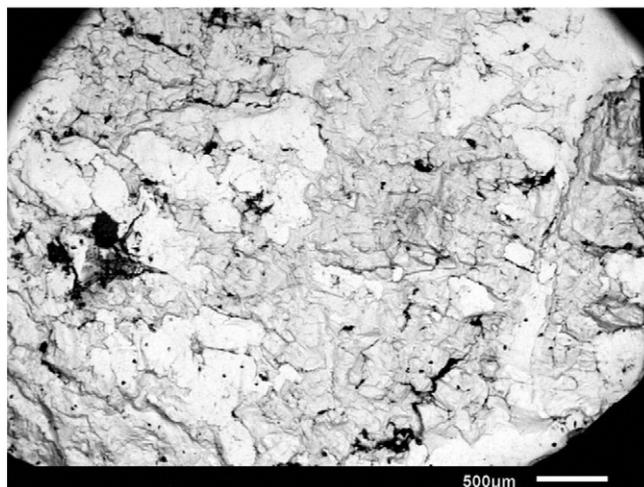
SEM representative image of section “A” is shown in Fig. 4. This image presents the fracture surface of the failed supracondylar plate. In this surface at least two regions are evident, one of them are rough zones distributed in the fracture surface; these regions are associated with striations, the other region corresponds with flat and more white zones; these “flat” zones observed in the fracture surface were related to fracture surfaces damaged by cyclic contact in the first stage of cracking previous to the complete separation of the plate.

The point of crack initiation is not clearly observed; however it is possible to see a line of crack propagation. Fig. 4 in backscattered electrons provides contrast based on chemical composition and there is no evidence of inclusions or corrosion artifacts in the fracture zone.

Fig. 4. Backscattered electron SEM image showing the fracture surface details.

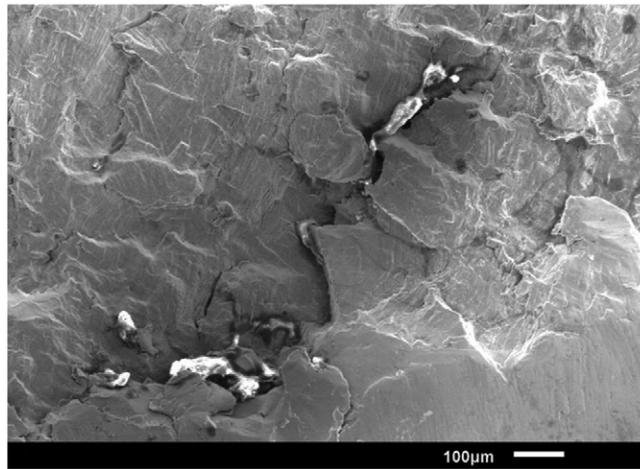
The results of the fractographic analysis indicated that the fracture morphology from the supracondylar plate corresponds with a common fatigue and finally cleavage decohesion of fracture (Fig. 5). This mode of fracture could be associated with fretting and mechanical fatigue under low stresses; fatigue striations are observed in the surface in the same direction that the crack was presented. According to Fig. 1 the compression plate could be working at least under unidirectional bending although it is known that the stress state during service could be more complex including combined compression, torsion, flexion, or bending and this condition promotes this mode of failure.

Fig. 5. Secondary electron SEM image of the fracture surface.

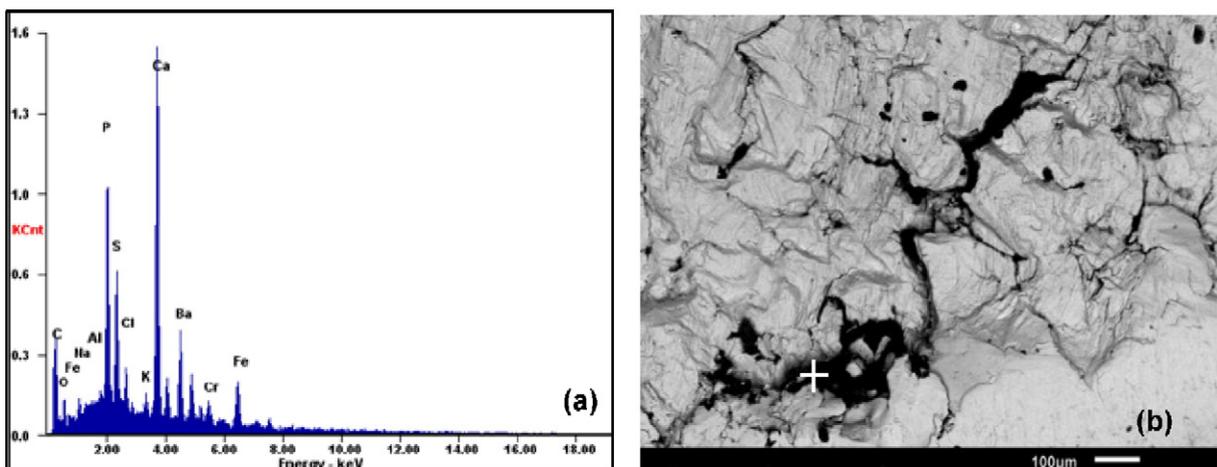
Fig. 5 shows artifacts in the crack zone; these were analyzed by EDS (Fig. 6(a)), and the qualitative chemical composition showed Ca, P, K, C and O, indicating that the material attached in the crack corresponds with biological fluids that remain.

Fig. 6. (a) EDS analysis in the (b) crack artifacts, region of analysis identified (+).
